# Impact of Curling, Warping, and Other Early-Age Behavior on Concrete Pavement Smoothness: Early, Frequent, and Detailed (EFD) Study

**Phase I Final Report  
December 2005**

**Sponsored by**  
the Federal Highway Administration (Project 16)

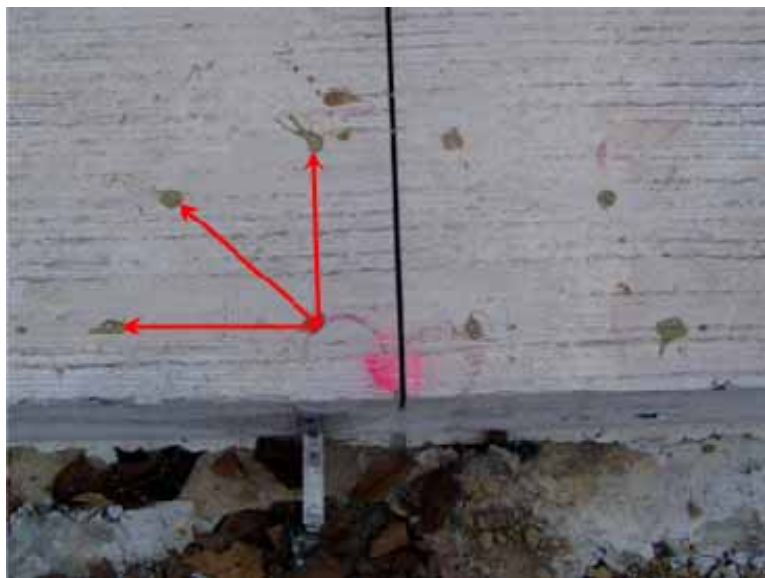
**Figure 9. DEMEC points in the “peacock” pattern**

To aide in the characterization of slab curling and warping, it was necessary to characterize the movement of transverse and longitudinal joints immediately following construction, as well as during diurnal cycles. Beginning shortly after construction, the project team attached stainless steel discs to the pavement surface to be used with DEMEC caliper measurements. Figures 9 and 10 show the discs on the concrete surface for joint movement and surface strain measurements, respectively.

- nine successive transverse joints, to measure joint movement
- eight successive longitudinal joint locations, to measure joint movement
- two “peacock” patterns at slab corners, to measure surface strain (CTE)
